# ANNUAL REPORT FOR 2011

**UT to Middle Fork Creek Site C Mitigation Site  
Madison County  
TIP No. R-2518A**

Prepared By:  
Natural Environment Unit & Roadside Environmental Unit  
North Carolina Department of Transportation  
December 2011

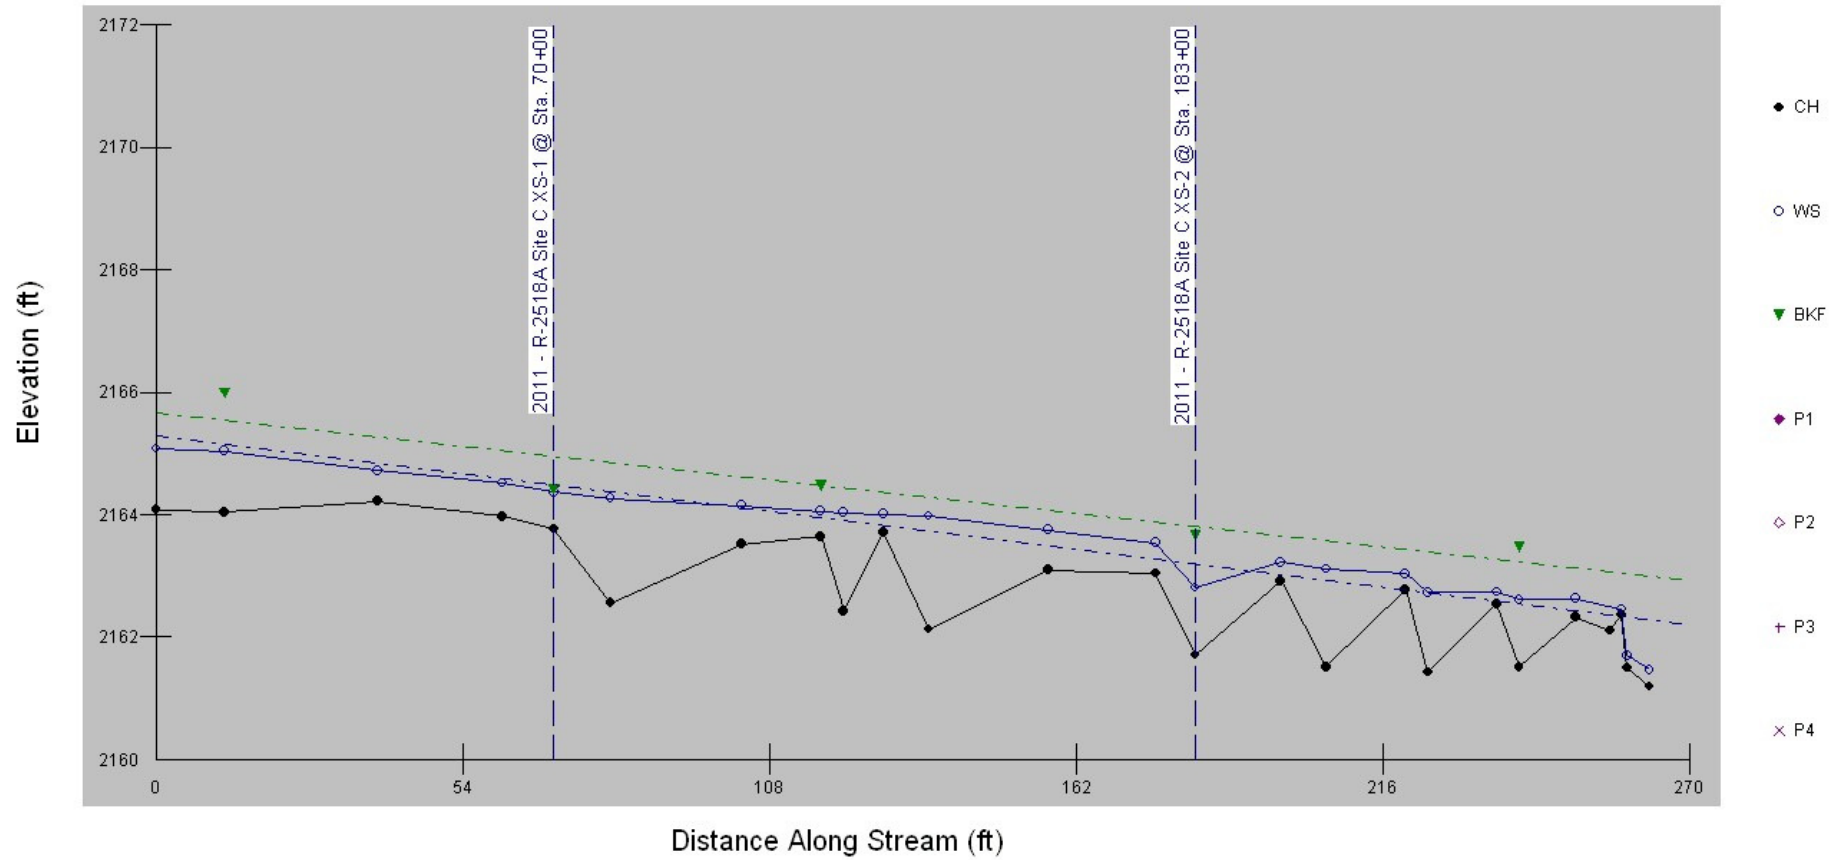
# 2011 R-2518A Site C Profile

Based on comparisons of the As-Built to the monitoring data, all of the cross sections appear stable with little or no active bank erosion. Graphs of the cross sections are presented in Appendix A. Future survey data will vary depending on actual location of rod placement and alignment; however, this information should remain similar in appearance. The longitudinal profile showed that the channel was stable for the 2011 monitoring evaluation. Pebble counts were not required per the permit conditions and therefore were not completed.
